# Blistering of epoxy industrial floor on concrete substrate: phenomena and case study

# Case study: conductive epoxy floor layer at ACE Electronics N.V., Diest [8]

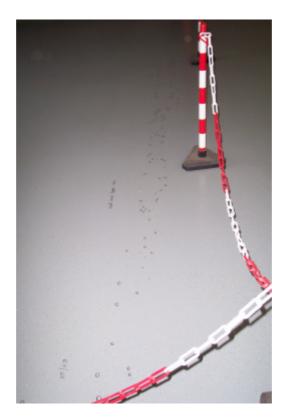
Within a month after the placement of the epoxy floor, blistering was observed. First, the blisters could only be observed near the expansion joints which were filled with epoxy-mortar. At a later stage, blisters could also be observed at other places.

Fig. 2. Blistering near expansion joint

It is remarkable that the blistering does not occur directly above the expansion joints, which would be the most obvious, but in a range of 5 to 10 centimetres next to this joint. This must be related to the fact that when filling the joints with epoxy-mortar a kind of smearing of the mortar occurred around the joint. So the blistering occurred in the transition zone between the smeared epoxy-mortar and the epoxy-floor.

To determine the cause of blistering three core drillings were executed and some blister fluid was sampled. During the sampling of the fluids, two differences could be observed and smelled. The fluid in the blisters in the zone of the expansion joints had a typical pine-oil smell. The fluid in the other blisters had a phenol resin smell.

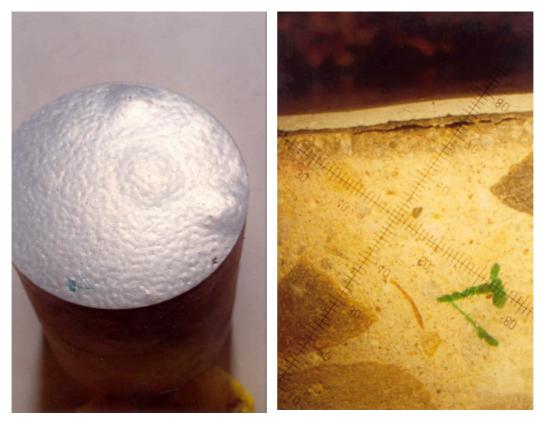
The results of the core drilling revealed that the debonding always occurred in the contact surface between the concrete and the epoxy floor. In none of the cores a debonding within the floor system could be observed. A typical view of a concrete core with blisters in the epoxy flooring is shown in figure 3. A microscopic view of a spliced core is shown in figure 4. In this figure the debonding can be observed.

Fig. 3. Core with blisters

Fig. 4. Debonding

The main reason for blistering occurrence at this site was osmosis. The penetration of primer in the porous concrete created a semi-permeable membrane. Also the smearing of the epoxy mortar near the expansion joints caused the formation of a semi-permeable membrane. Due to the difference in concentration of soluble material in the concrete and in the epoxy-floor layers, a diffusion of water occurred, which resulted in the formation of blisters. Due to the low temperature during the placement of the epoxy system, the epoxy system could not react fast enough to ensure a proper binding. By that, the concentration difference was present for a longer period, thus the formation of osmotic blisters was more likely to occur.

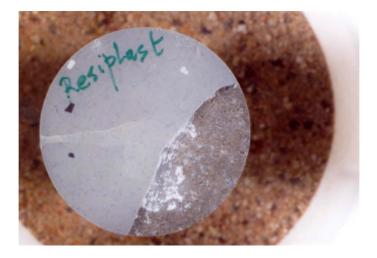
A core, drilled by the contractor revealed a white deposit underneath the debonded surface of the epoxy flooring. The blister fluid was no longer present.

Fig. 5. Core with white deposit

An XRD analysis of the deposit revealed that it was amorphous. A further EDX-analysis revealed the presence of potassium and silicon in the amorphous deposit. Only a small amount of calcium could be observed in the deposit. The presence of both potassium and silicon in an amorphous deposit could indicate the presence of reactive aggregates in the concrete resulting in the formation of highly hygroscopic water glass (alkali-aggregate reaction), which could also cause blistering, as already mentioned.
